Learning From the Residents

by Jim LaRue

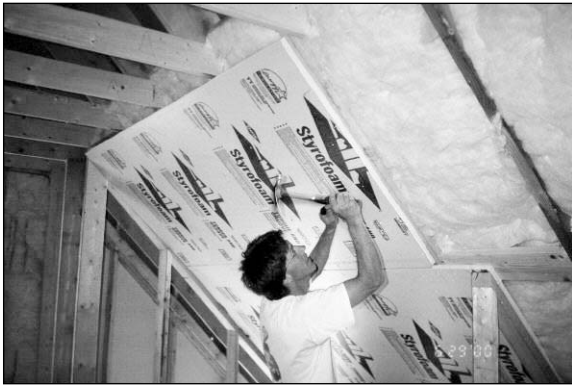
(opposite page) Careful moisture flashing details around all windows keep water out of the walls at the most vulnerable points. (above) One-inch foam sheathing on the interior of cathedral ceilings combined with thorough air sealing helps stop heat transfer through the framing members.

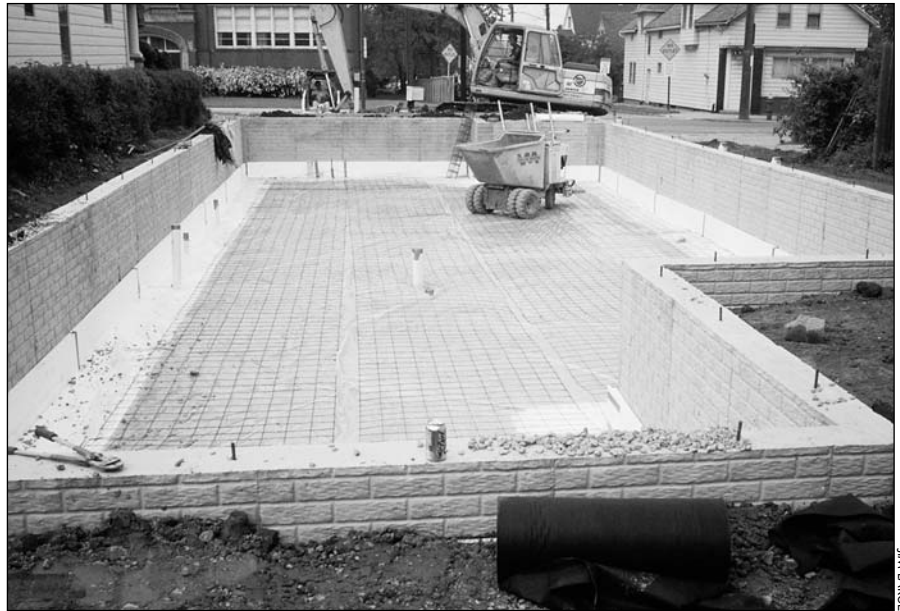
Two-inch foam panels under the slab and up the walls of the crawlspace not only reduce heat loss, but also greatly reduce the chance of condensate forming on the slab.
